Sanctuary

ON THE DRAWING BOARD:

Analysis of a bushfire loss

Late last year, a house designed by Dick Clarke of Envirotecture burnt to the ground in the Gospers Mountain bushfire. Dick investigates why the house burned, and what can be learned to help rebuild it and other houses in fire-prone areas so that it's less likely to happen again.

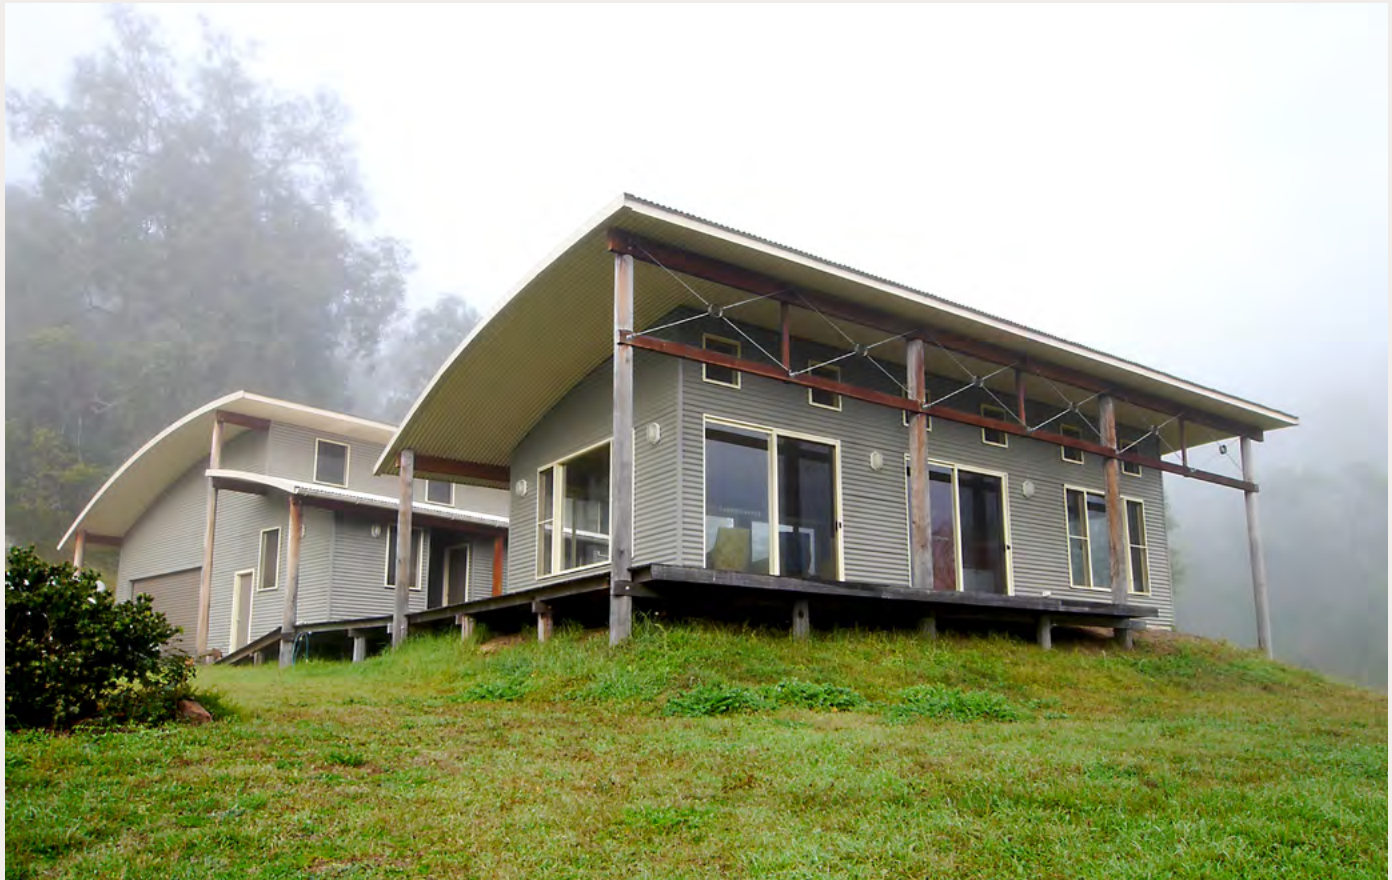
This small house in Laguna, with two-storey shed behind, was designed prior to the introduction of Bushfire Attack Level ratings and building requirements.

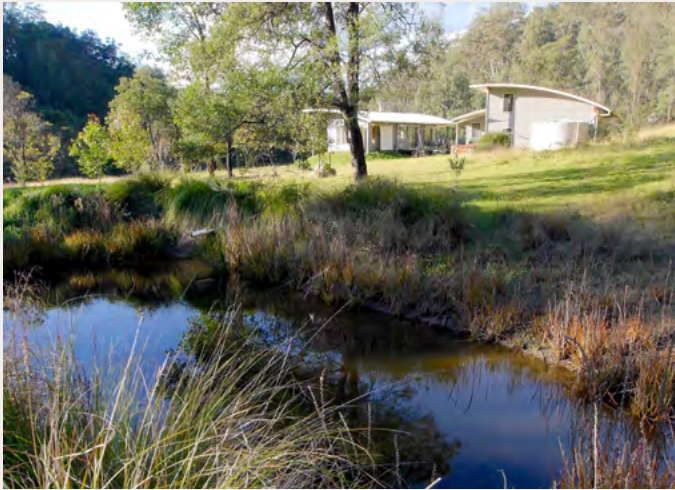
↑
The asset protection zone (APZ) around the house was extensive on the east, north and west.

The buildings sat on relatively level ground, with a small fall to the north. The asset protection zone (APZ) around the house was open pasture, except for a small copse of white cedars to the north of the cottage that was separated from any other tree canopy by more than 100 metres. The APZ extended more than 50 metres to the west, 100 metres to the north and 200 metres to the east, but only 15 metres to the south, where a steep rising slope supported open forest and sandstone outcrops. The prolonged drought had reduced the ground cover from the usual grass to a sparse stubble, with a lot of bare ground showing between tufts. This APZ was well in excess of that required by either the old or current bushfire construction code.

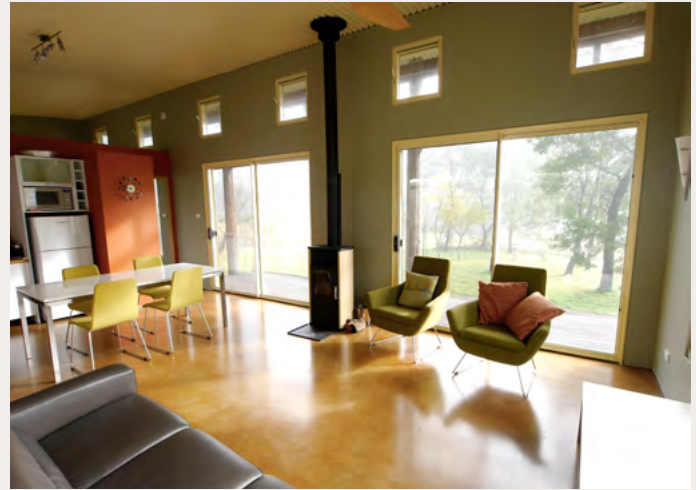
↑
The house was owner-built over several years. It was a combination of post-and-beam and lightweight timber frame construction with Colorbond cladding and SIP roofing.

The slab-on-ground buildings employed a combination of loadbearing timber-framed construction and post-and-beam construction with non-loadbearing timber-framed infill walls. Structural insulated panels (SIPs) were used for the roofs. The wall framing was radiata pine and the exposed beams and poles were dense Australian hardwood.

Colorbond cladding was installed over non-fire-rated foil sarking, which was compliant at the time, although this is no longer acceptable practice. Walls in the cottage were insulated with two layers of concertina foil batts. Windows and doors were all aluminium-framed single glazing and louvres, with metal flyscreens. The roof was made with the old Ritek SIP system that used EPS foam and two skins of corrugated Colorbond; the manufacturer has a better option now.

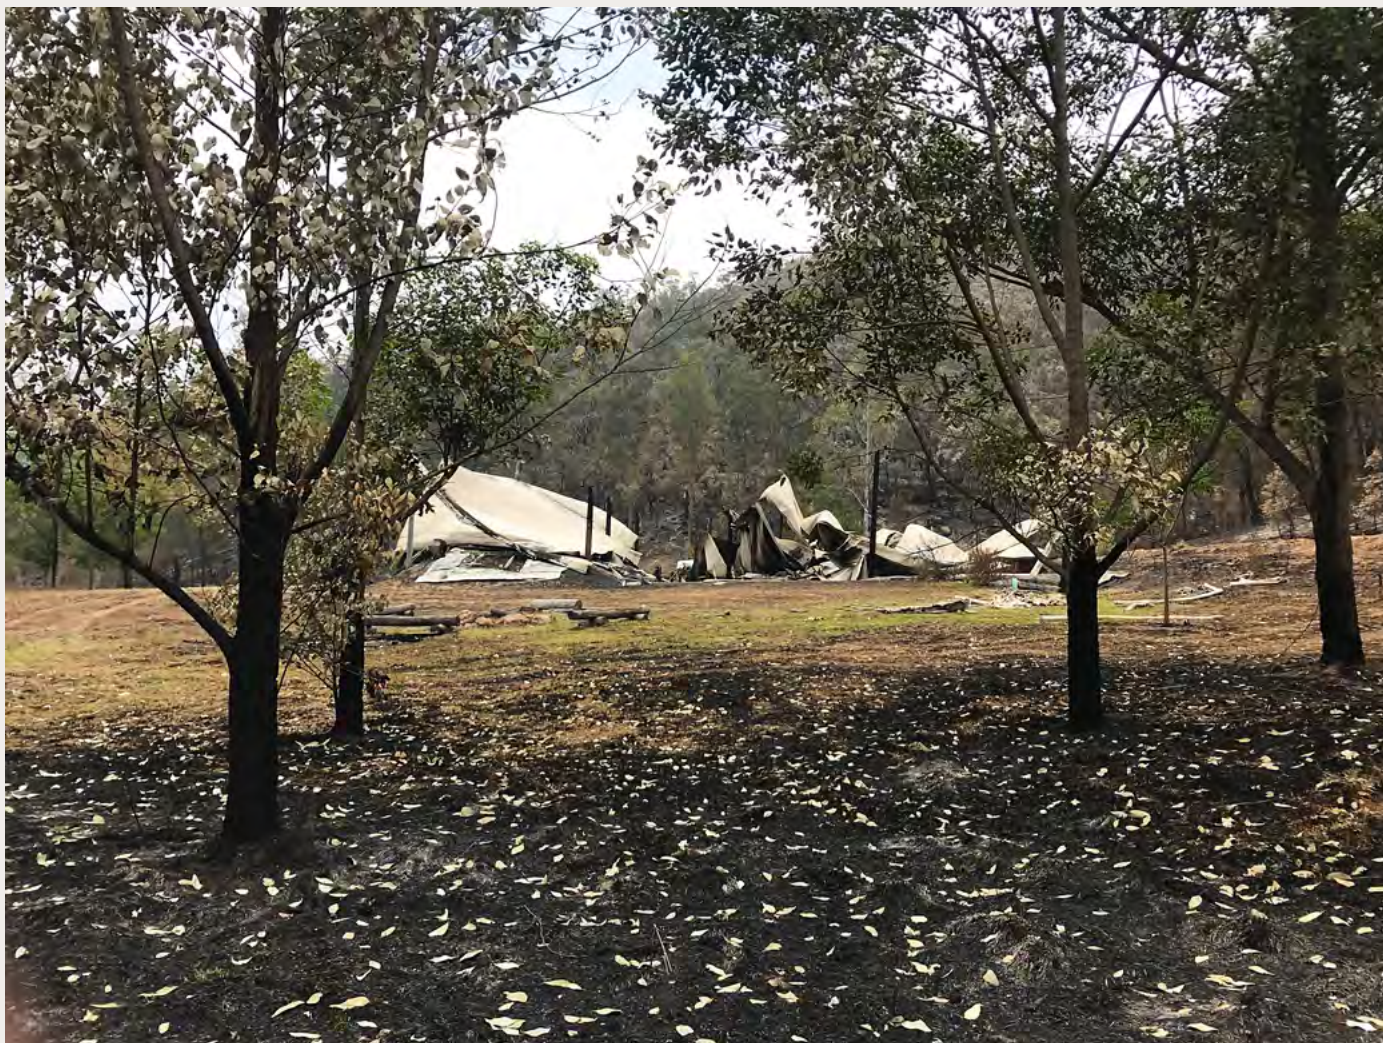
After the fire, it was a sad scene. Patches of unburnt grass around the buildings suggest that it was embers that set the buildings alight, rather than a fire front.

Without an eyewitness account of the loss of the cottage, we can only look at the remains to try to reconstruct the process of destruction. A heavy and sustained ember shower probably preceded the main fire front, but the patches of burnt and unburnt grass around the buildings show that no advancing ground fire reached them. No trees close to the house means there was no direct ignition from burning tree canopies; in fact, the white cedars remained unburnt.

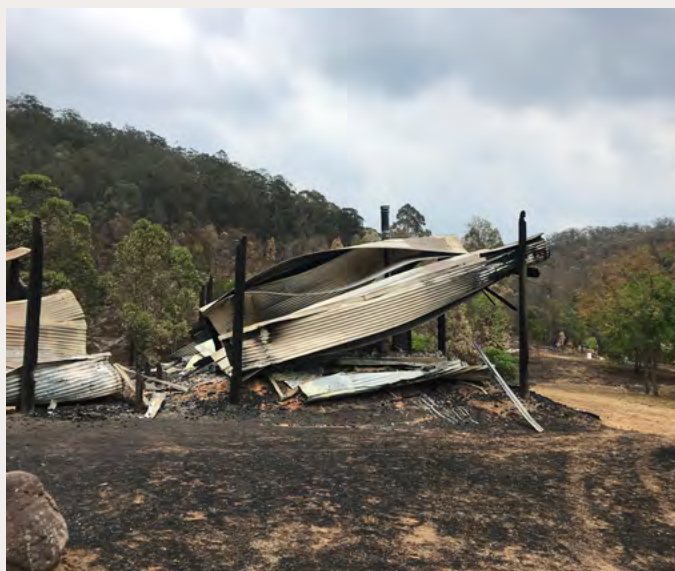
Both structures, the shed and the cottage, are a total loss. The timber poles and framing are badly charred or burnt completely. The EPS core of the SIP roof panels has turned into greenhouse gas and headed for the stratosphere, leaving the two skins of twisted corrugated steel slumped over whatever was below them, the long screws that fixed them to the walls still hanging in space.

↑
The pine framing burnt completely, but the blackened ironbark poles remain standing amongst the cladding and roofing sheets.

The wall and roof frames can be timber again, and Colorbond is still the best cladding choice, but this time over a fire-rated substrate layer and insulation. Roof overhangs will be supported on steel outriggers and battens – no timber up there, not even ironbark. It is critical that embers are prevented from entering cavities in roofs and walls, especially at edges and junctions. We will use fireproof felt seals and stainless steel mesh with

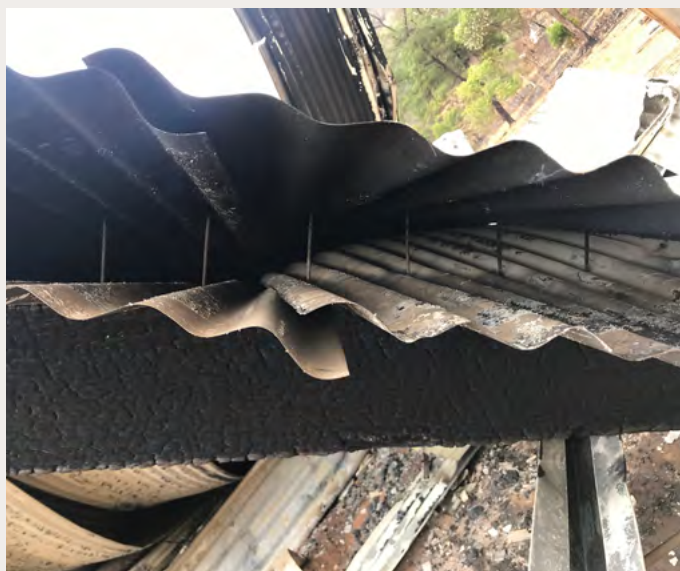
- The timber decking: Though the deck was built from timbers on the 'approved' list for fire resistance, the list assumes that there will be human intervention to prevent ignition. Without it, enough embers landing on any species for long enough will cause it to burn. Once the deck was alight, the base of the adjacent walls would have been subject to extreme heat, and the wall frames likely then caught fire.
- The roofing: It is possible that embers got in through flashing gaps and immediately ignited the EPS core of the roof panels, which is highly flammable. This is one more reason to eliminate EPS from our palette of materials. ARC Panel, the newer version of this roofing system, uses fire-retardant PIR foam in its BAL-40 rated product.

↑
The Colorbond skins of the roof SIPs are still screwed to the tops of the walls, but the EPS core is gone.

openings less than three millimetres to achieve this. Magnesium oxide or fibre cement decking would be ideal, over a steel frame. And no EPS anywhere.
